SEELEYS MILL DAM

NJ 00065

PHASE 1 INSPECTION REPORT
NATIONAL DAM SAFETY PROGRAM

April, 1979

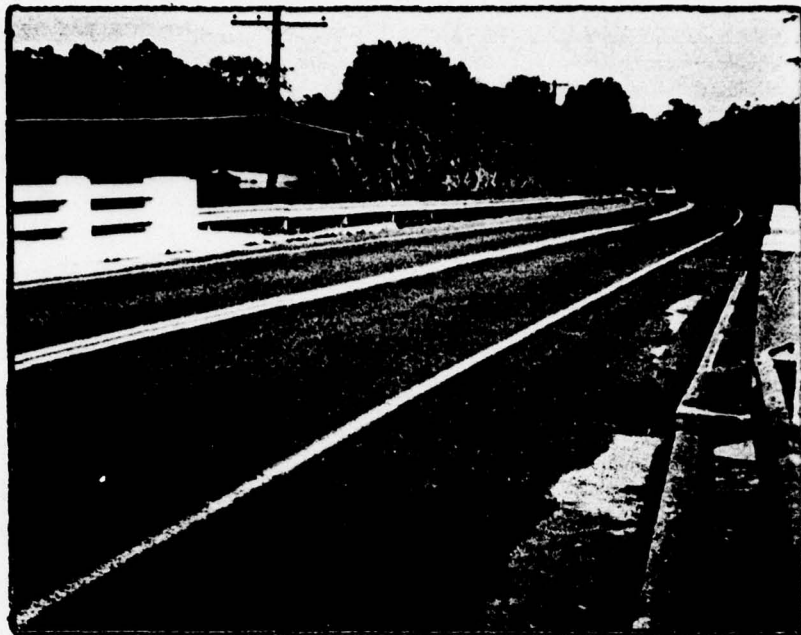
The upstream side of the roadway shoulder to the left of the spillway has a narrow crest width of only 5-10 feet and is slightly above the roadway pavement. This crest zone, together with the 150-foot dike which extends back up along the east shore and forms the right abutment are in a loose, bulked condition. The crest is very narrow in numerous areas and would be highly susceptible to washouts if overtopped. Except for economic considerations, it is not clear why the 1956 road design continued the profile grade downward to the intersection of Finley Road and the Deerfield-Seeley Road which runs along the east shore of Seeleys Pond. This intersection is several feet below the dam crest and provides a potentially breaching zone, especially along the 150-foot spur which is poorly maintained and covered with heavy brush and several large trees. This places the narrow berm of fill along the north shoulder of the roadway and the re-entrant dike in a rather

View East along dam crest (Cty. Rte. 617)

- The upstream zones of the embankment crest should be rebuilt with a berm of uniform width and level elevation so that the full spillway capacity can be utilized.
- The trees and root systems should be removed from the upstream slopes and the slopes protected.
- The 48" sluice gate should be repaired and its entrance unplugged.

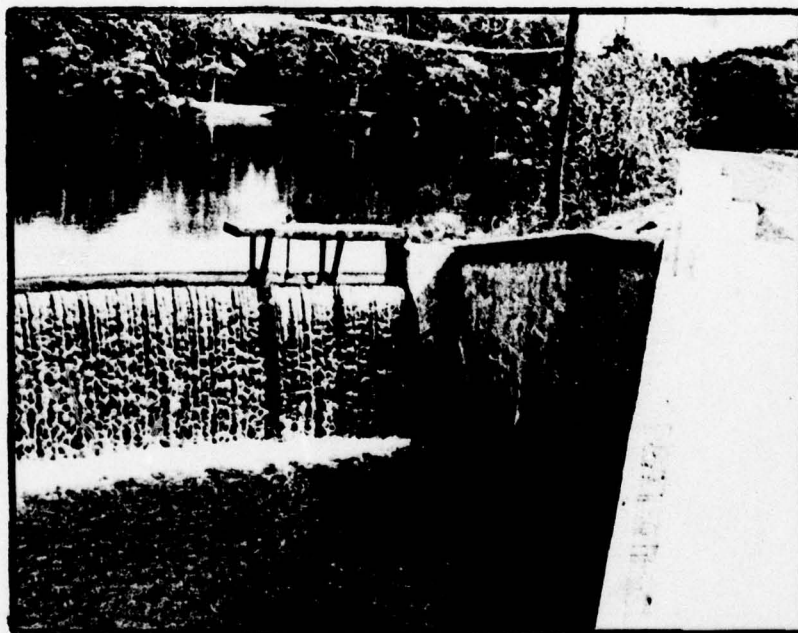
Nothing was observed by the inspection team regarding operational procedures. The sluice gate has apparently been inoperative for many years and the dam has functioned completely as an uncontrolled overflow structure.

48" ϕ sluiceway at left end of spillway

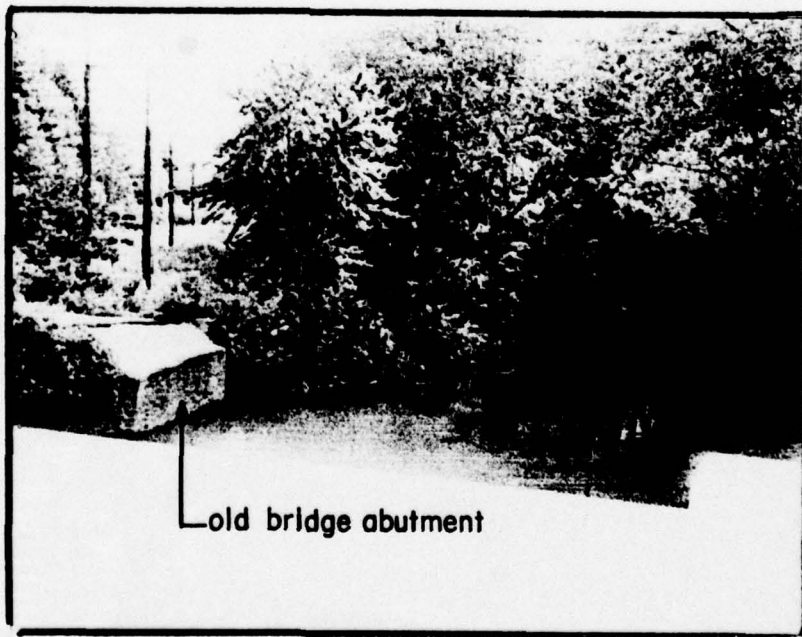
The spillway and the paved invert beneath the bridge appears to operate satisfactorily and show no evidence of damage from excess velocities. The downstream channel is not scoured out indicating the length of paved invert is sufficient for the energy attenuation.

Downstream channel

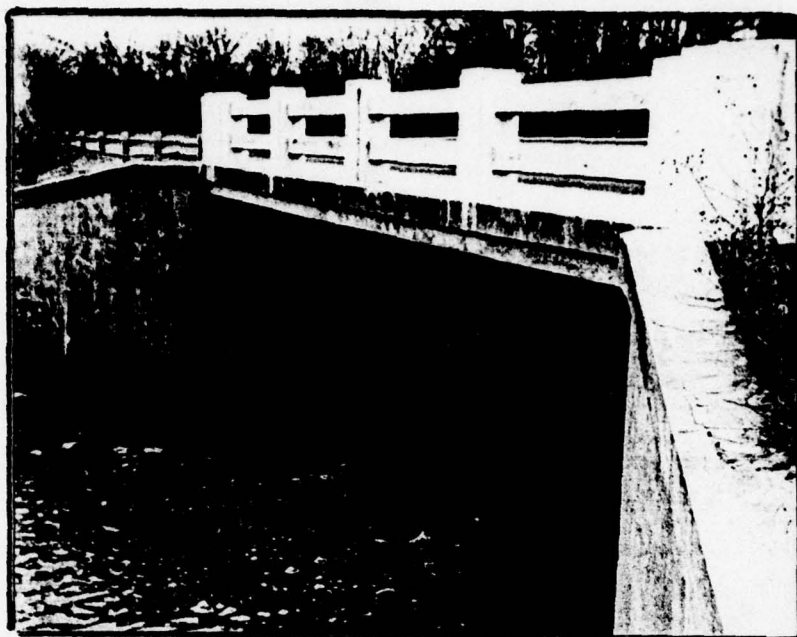
The highway bridge is in moderate to good condition. There is minor cracking and spalling of the concrete and the structural steel needs repainting but these conditions are of minor concern. The bridge is founded on piling and has negligible differential settlement or tilting.

County bridge just below spillway

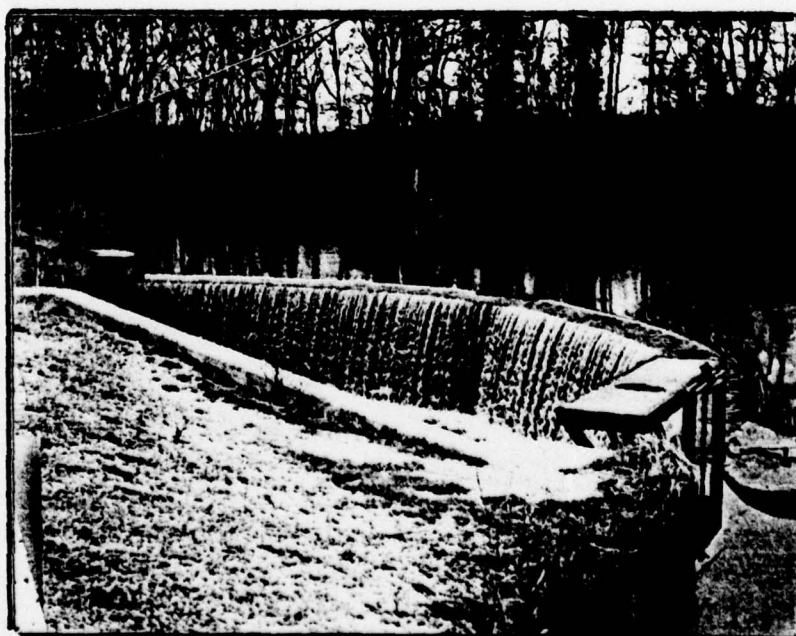
The circular spillway is built on a 45-foot radius and has a concrete crest width of approximately 18 inches. Due to the uniform overflow during the inspections, the condition of the lower steel sheetpiling could not be observed. The concrete cap beam appears to be at a uniform grade and there was no evidence of broken zones or pieces missing. The juncture with the thrust block at the end of the arch and the wingwall is tight and shows no crushing or horizontal movement. The bridge has a 12-foot clear headroom between low steel and the 8-inch invert slab. Approximately 30 feet of steel sheet piling extend along the upstream face paralleling the dam axis each side of the north wingwalls. The 48-inch vertical lift slide gate is inoperable and from rough soundings taken near the entrance, its entrance is completely silted up.

Spillway
